Brisbane Central Business District Bicycle User Group

I refer to the death on 24 February 2016 of a cyclist who reportedly crashed under the Go Between Bridge on 12 February 2016.¹ The circumstances of the crash are currently unknown to us; however, there are a number of issues with various parts of the bridge that we consider poor design and hazardous to people riding bicycles. Under the Safe System approach recommended by Austroads, and encouraged by the Department of Transport and Main Roads, the following hazards should not have been designed in. We ask for their remediation as soon as possible.

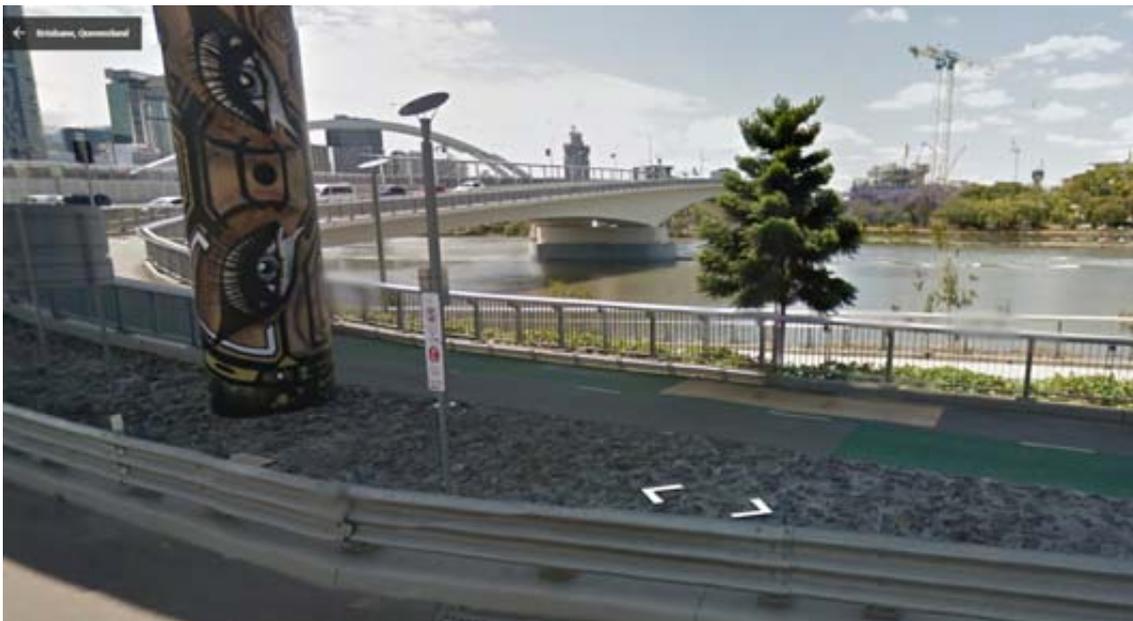
3. The jagged concreted rocks on the run-off area on the northern side as per the attached photograph. Should a cyclist underestimate the degree to which they need to slow down to negotiate the corner, they are likely to roll over these rocks and totally lose control. Having lost control, any injury they sustain will likely be significantly worsened by the presence of these rocks. This surface needs to forgive human error, and recognise the frailty of the human body.
