**Brisbane Central Business District Bicycle User Group**

This letter concerns the serious traffic crash on Braun Street, Deagon, on 16 December 2015.<sup>1</sup>

The crash occurred adjacent to works being undertaken for the Department of Transport and Main Roads (TMR) – the Gateway Upgrade North project. PCBs (precast concrete barriers) had been placed in the shoulder to protect workers on the project, but these had the effect of forcing people riding bikes in the area out of the shoulder and into the main traffic lanes with little warning.

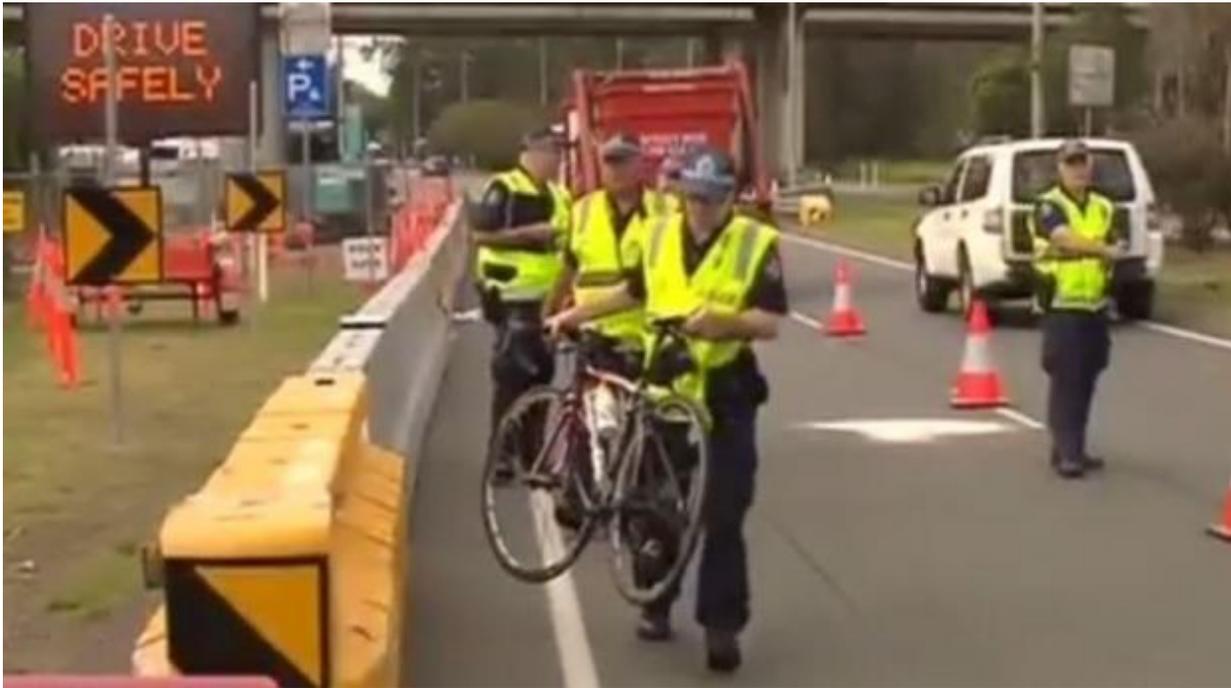
No mitigations such as speed limit changes (apart from the covered “70” sign) or traffic controllers were in place. A similar situation with a disappearing shoulder occurs near the Gympie Rd / Anzac Ave intersection (Appendix), but with traffic lights and a crest rather than a suddenly disappearing shoulder. Here drivers may have been expecting to increase speed from 60 to 70 km/h with a straight road. Judging by the videos some drivers also experience “lane fixation” here, further increasing the risks.

Figure 1: Photo from Brisbane Times illustrating location, “70” speed limit sign covered on right, “Changed Conditions, Drive Safely” sign partially obscured.

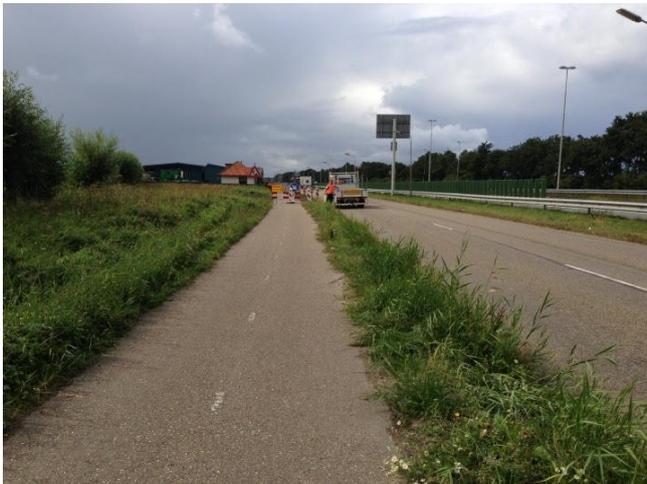
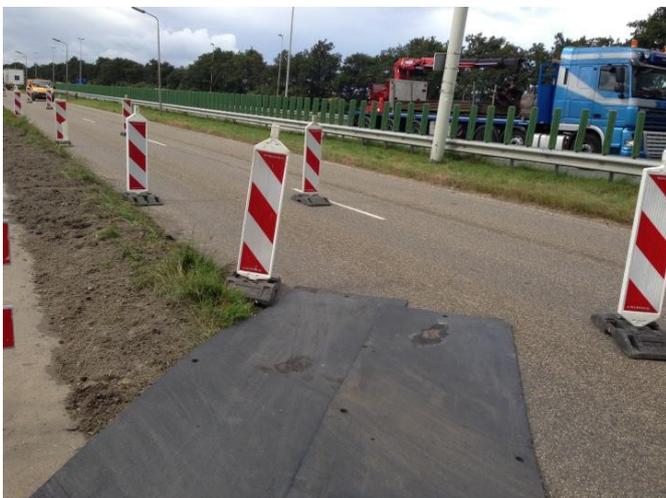
The Appendix shows an example of a truly “world class” alternative from the Netherlands where work is occurring on a bike path.

Figure 2 and 3: Examples of how bike path works are carried out in the Netherlands, with a facility of equal amenity and safety being provided.

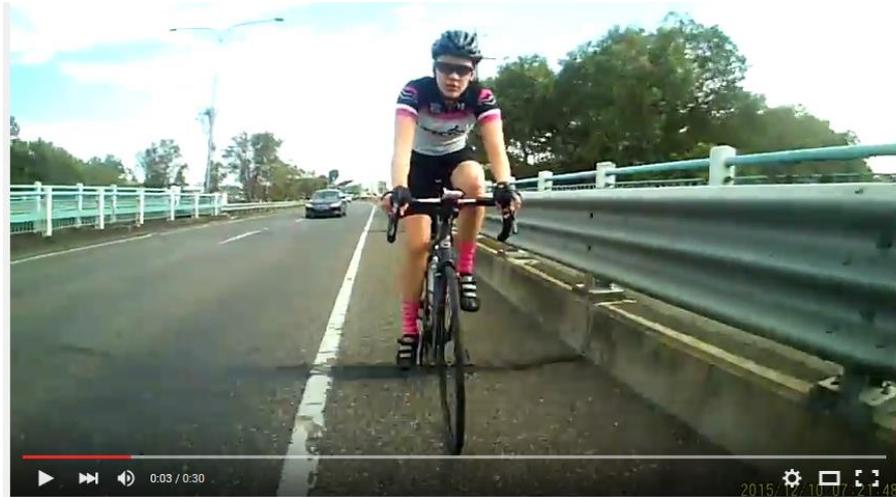
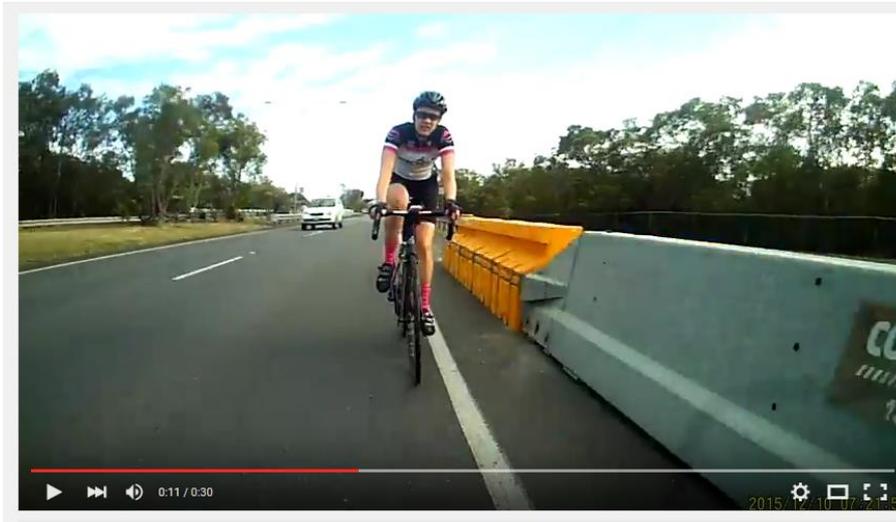
Video 1 and 2: 10 December 2015 rear view. This illustrates the forced change in lateral position before the incident with little warning available.

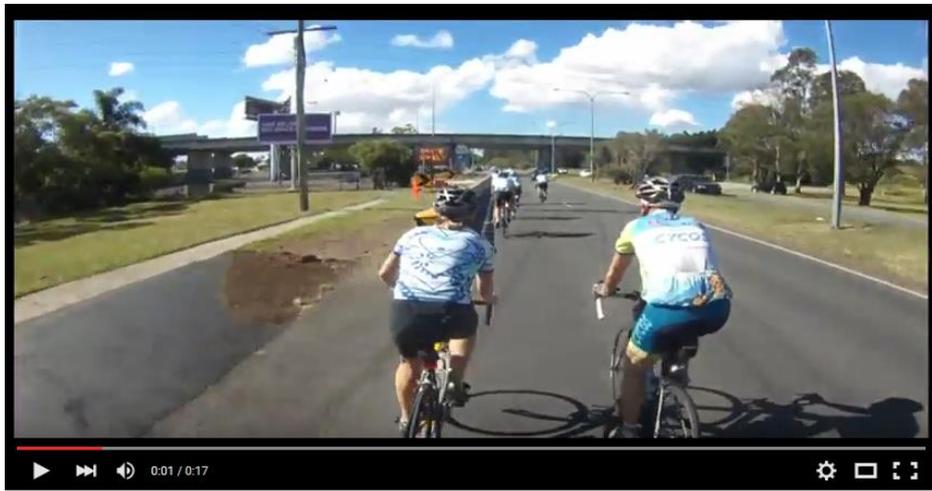
Video 6: 20 December 2015 front view. This illustrates how the view of the barrier may be obscured in a group.

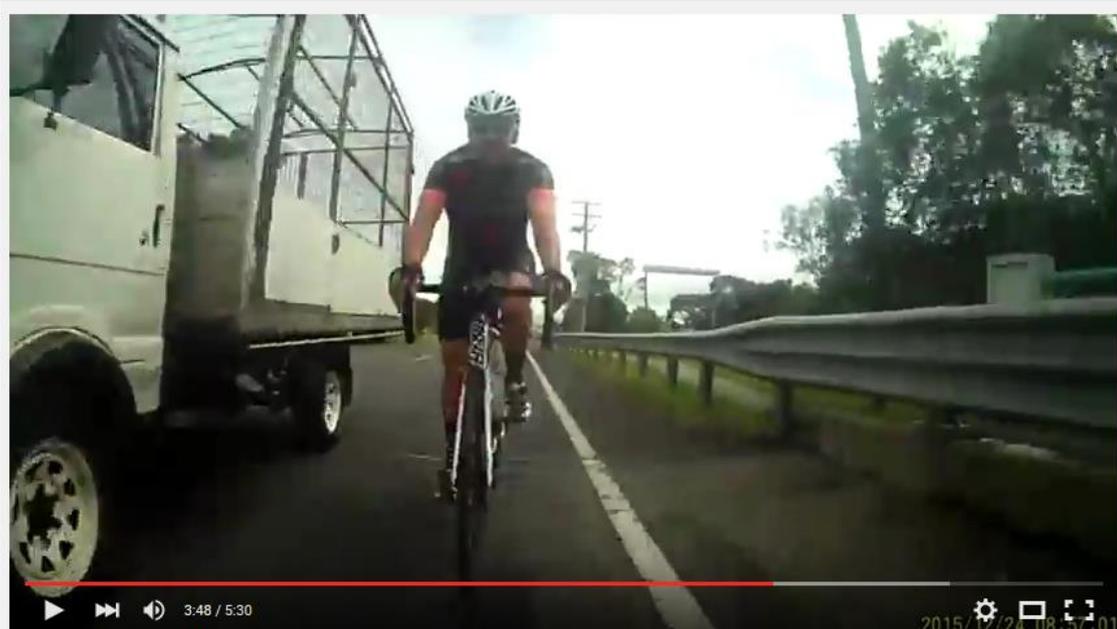
Video 7: 24 December 2015 rear view

Note that a close pass occurs at 3:48 despite an attempt by the rider to ride out of the shoulder so as not to run into the PCBs – barrier footage at 3:45 to 4:10

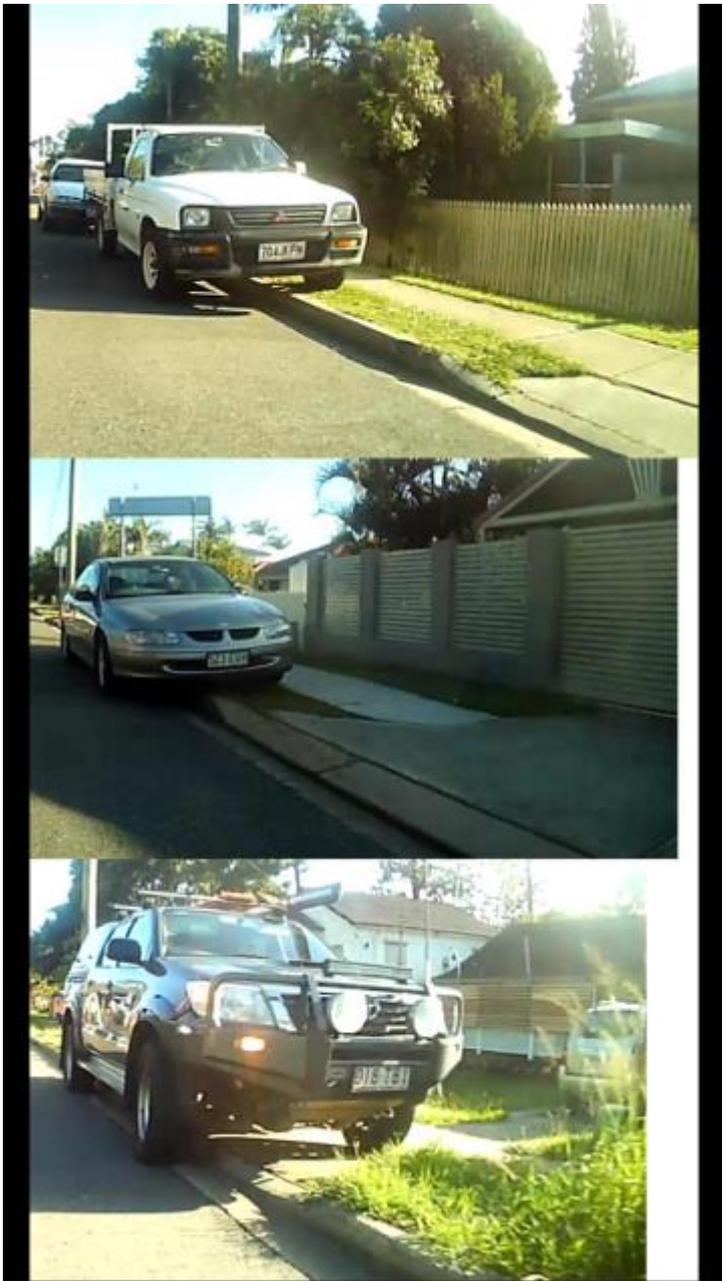
The shoulder in this area connects directly to the Sandgate Road bike lanes pictured. This area has issues for people riding bikes in the block north of Carlyle St / Roghan Rd - poorly parked cars leave very little room in the shoulder or are parked half on the nature strip (see Appendix).

Figure 4: Parking issues north of Carlyle Rd – photos from complaint to BCC – 13 March 2015
