## Brisbane Central Business District Bicycle User Group

I write to you on behalf of Brisbane Central Business District Bicycle User Group (CBD BUG) members regarding the continuing safety issues of the Goodwill Bridge deck resurfacing.

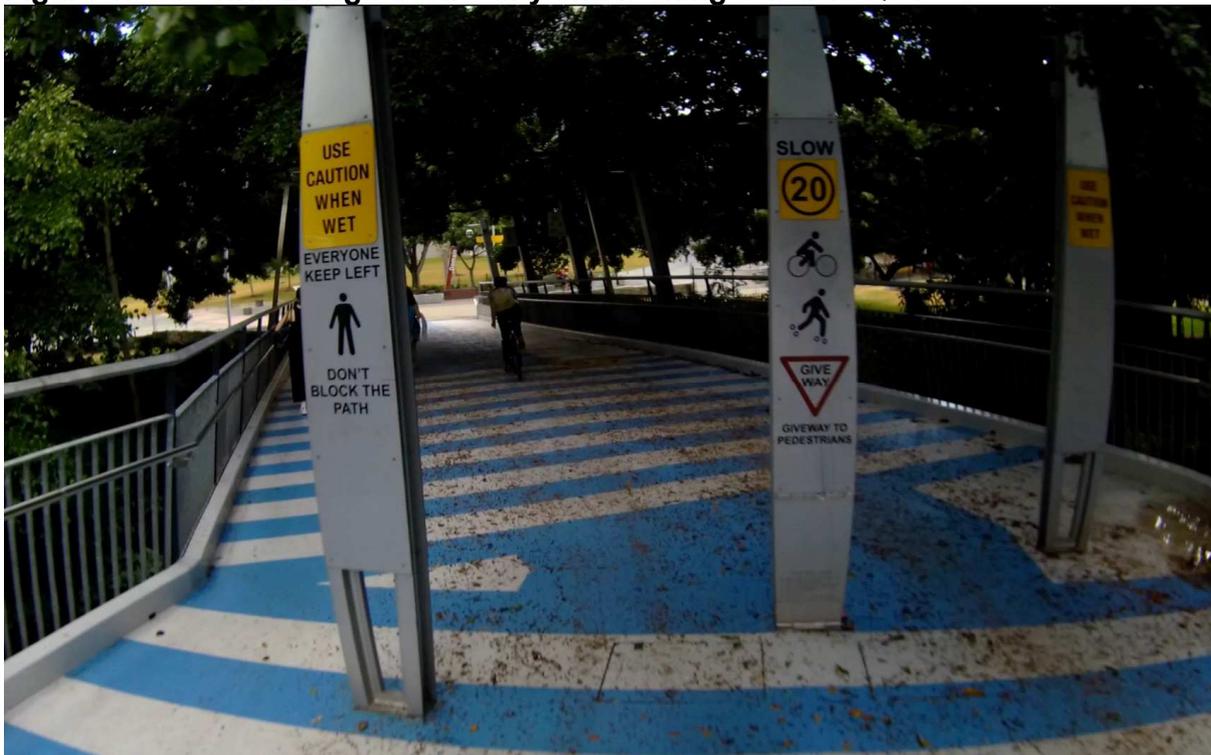
**Figure 1: Goodwill Bridge deck – city end looking towards QUT**

As you are aware the works carried out by the contractor for the Department of Housing and Public Works in 2017 were not up to a standard that allowed for a person riding a bike to safely descend or even ascend the Goodwill Bridge without the potential for a bicycle to slip / skid out from under a person. Since that time the CBD BUG is aware that an additional abrasive layer has been added to the surface coating. While this may have reduced incidents of bicycle skidding slipping out from others it has not fully resolved the issues.

After early morning rain on 25 January 2018 the CBD BUG observed/ fielded reports of at least 10 people that had fallen from bikes due to the bridge's slippery surface. One report involved the very concerning matter of an elderly gentleman suffering a broken pelvis. Figure 1 on the following page shows the location where most of the falls occurred, which is at the City (northern) end of the bridge.

As can be seen, while there is a slight layer of organic matter dropped from the trees this should not be used as an excuse for the abnormally high number of falls at this location, since organic matter on the path has been a factor for the entire existence of the bridge. The CBD BUG would also like to point out that there was also a report of person walking who slipped and fell. Hence, this is not an issue limited to cyclists or a matter of people riding too fast for the conditions.

The CBD BUG therefore requests that you take immediate action to have works undertaken to have the surface rectified. It appears that works and rectification works by the contractor have not resolved the issues. Compared with previous works performed to the bridge surface, it is not up to previous standards of safety and amenity.

The CBD BUG would also like to take this opportunity to once again request that the bollards at the northern landing point be relocated away from the bend to reduce their potential as a crash hazard - and be moved so that they are located no closer than midpoint between the bend and the end of the bridge.
